# Reducing blade damage caused by lightning

Arctura's ArcGuide<sup>®</sup> coating represents a groundbreaking approach in mitigating lightning-induced damage to wind turbine blades, a problem that costs the industry over \$100 million annually. Designed to alter the electric field surrounding the blades, the coating encourages the formation of lightning leaders at specific receptors rather than within the blade itself, reducing the frequency of punctures. Laboratory testing on GE 1.5sle blades demonstrated a significant 73% decrease in punctures at prevalent strike angles. This enhancement could substantially reduce both downtime and repair expenses for the wind industry. Recent studies corroborate the coating's potential to diminish these financial losses.

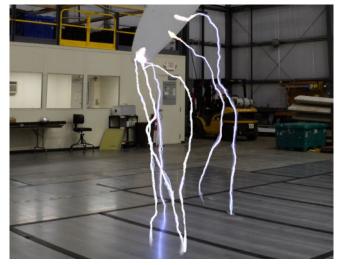
Figure 3 shows two composite images of all strikes to one of the blades hung at an angle of 60°. Each of the electrical arcs that span

from the blade to the floor represent one test, or 'strike.' Image processing was used to combine multiple shots into a single picture. The baseline configuration on the left shows most of strikes terminating at receptor, as desired. However, two strikes punctured through the blade further inboard.

In contrast, the image on the right shows the same blade hung at the same angle, but in this case the ArcGuide® coating has been applied. All shots with the coating terminated at the receptor. More testing was completed with three different blades hung at 60°, 30°, and 10° with respect to ground, each with and without the ArcGuide® coating.

The IEC standard summarises lightning risk, testing, and general protection requirements for the wind industry. The standard calls for the blade tips to be suspended over a ground plane with the receptor at high voltage. The blades were tested at angles of 60°, 30°, and 10° with respect to ground. Shallower angles are harder to protect as the electric field is increased inboard and away from the tip receptor.

The blades coated with the ArcGuide<sup>®</sup> coating performed significantly better than the blades without the coating. Blades that were coated incurred no damage when tested at angles of 30° or higher. For the difficult-to-protect 10° case, the blades with the ArcGuide<sup>®</sup> coating suffered half as many punctures as the baseline cases.
