How to upgrade your blades against lightning

Words: Allen Hall, Founder and CEO of Weather Guard Lightning Tech

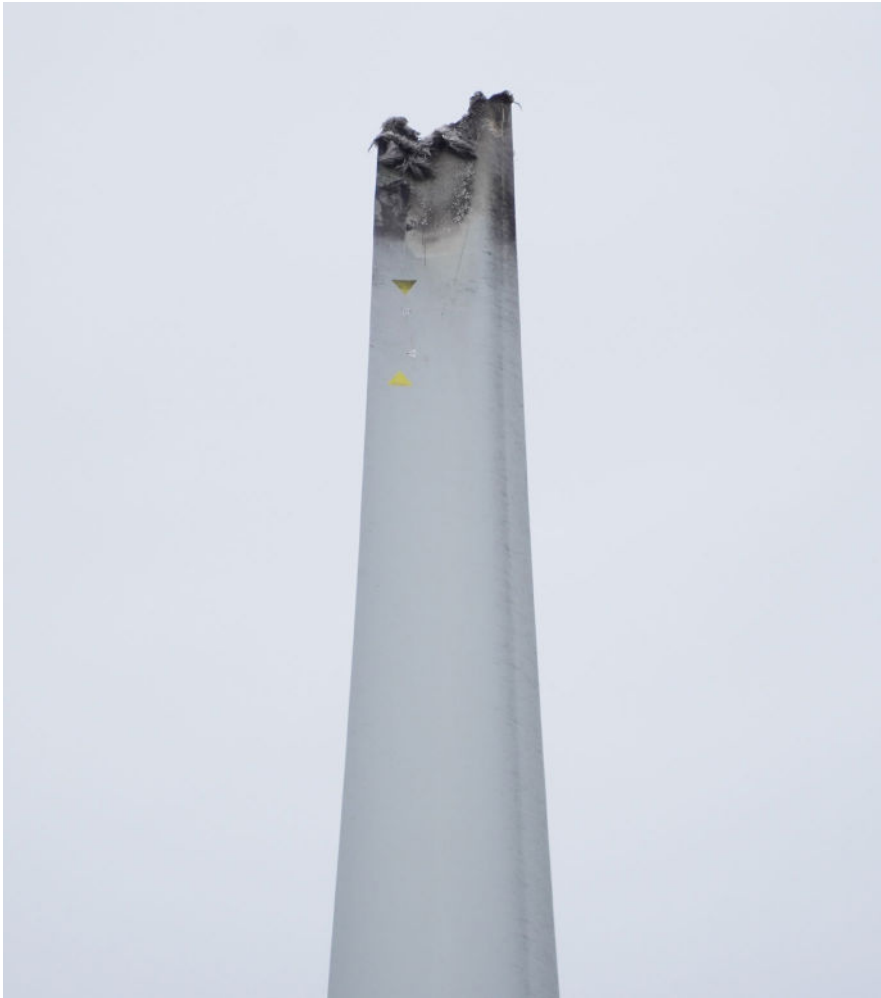
The GE 2.X-116 and 127 have a basic lightning protection system, consisting of a single receptor at the tip on both the pressure and suction sides of the blade. This system has been validated through the IEC 61400-24 standard to LPL Level 1. The intent of the LPS is to collect all lightning strikes at the receptors and then conduct the energy through an aluminum down conductor inside the blade, through to the hub, nacelle, tower and eventually to Earth. The LPS system is simple and has been reasonably effective through the years.

So, what is happening in Texas and Oklahoma? In simple terms, lightning is missing the receptor and puncturing the blade structure. I saw some blades with multiple holes from lightning strikes. These holes are easily detected because the damage peels back the outer strands of the laminate, leaving a streak of black on an otherwise white blade. Internally, the lightning will damage the blade structure to reach the insulated down conductor cable.

These blade punctures tend to be several meters from the receptors. Most of the damage I have inspected has been 3 to 5 meters inboard of the receptors, although some operators have reported damage further down the blade. Anecdotally, this would indicate that the LPS is effective at picking up strikes within about 2 meters of the receptors.

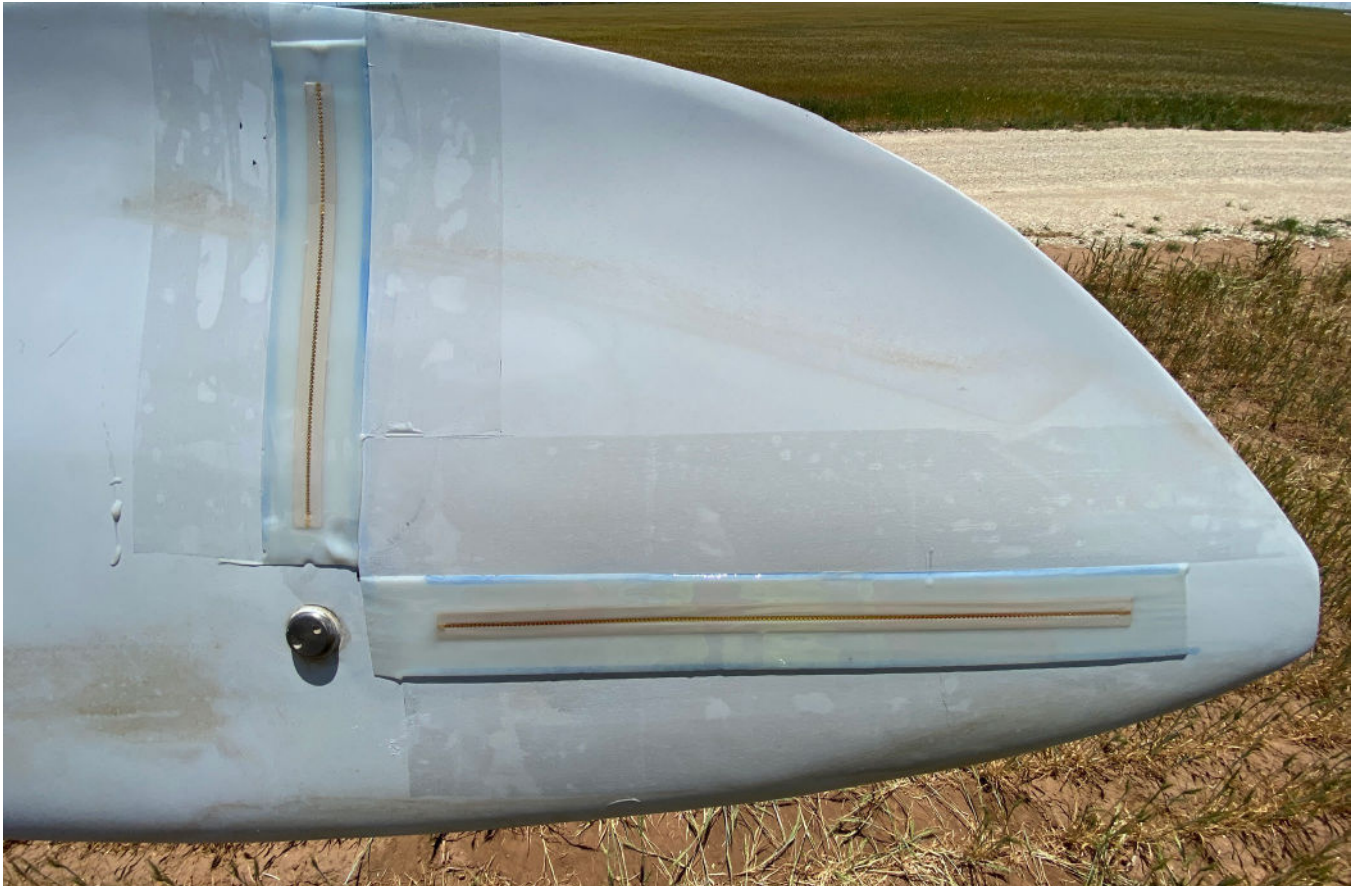
However, the long-duration current strikes can be preceded by a lower-voltage potentials during the initial phases of the strike. These low-intensity lightning events can evade the receptors and hit the down conductor.

Photos of such strikes are documented in the published papers 'Lightning attachment to wind turbines in central Kansas: Video observations, correlation with the NLDN and in-situ peak current measurements' and 'Lightning Attachment to Wind Turbines in Central Kansas: Video, Observations, Correlation with the NLDN and in-situ Peak Current Measurements in 2013' by Nicholas Wilson, et al.
